Analysis of the Pneumatic Burst of a Large Seamless Steel Pressure Vessel in Natural Gas Service

NBSIR 78-1589

Failure Analysis Report

December, 1978

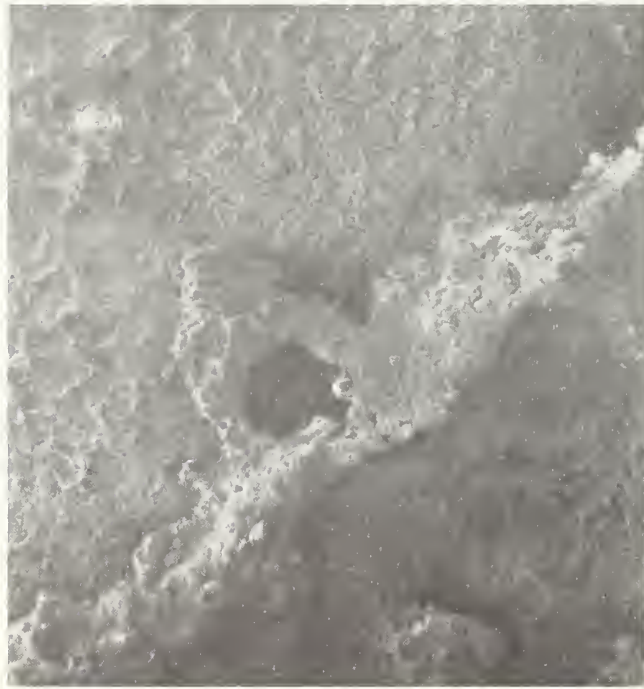
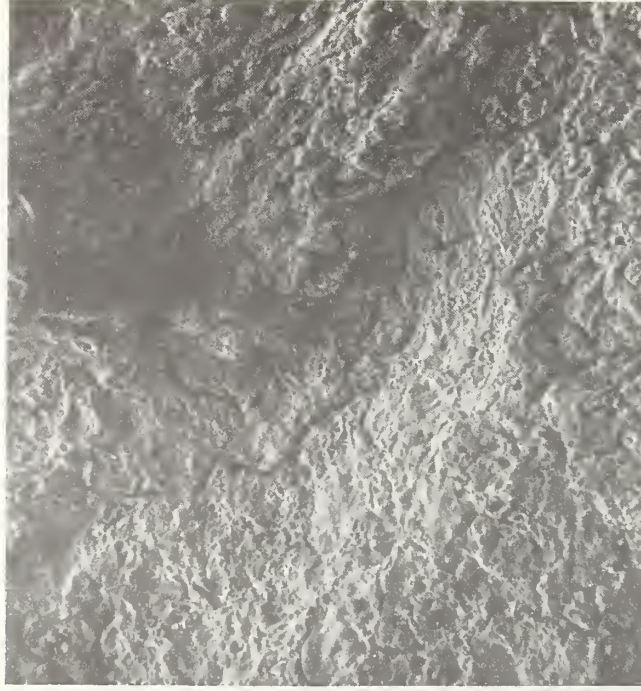
Figure 20. The inside wall of specimen TR-5 near the fracture origin after partial solution cleaning. (a) Low magnification view of uneven regions. (Remaining surface product runs from 2 o'clock to 8 o'clock) (b) Uneven region at higher magnification. (Photo obtained in scanning electron microscope.)

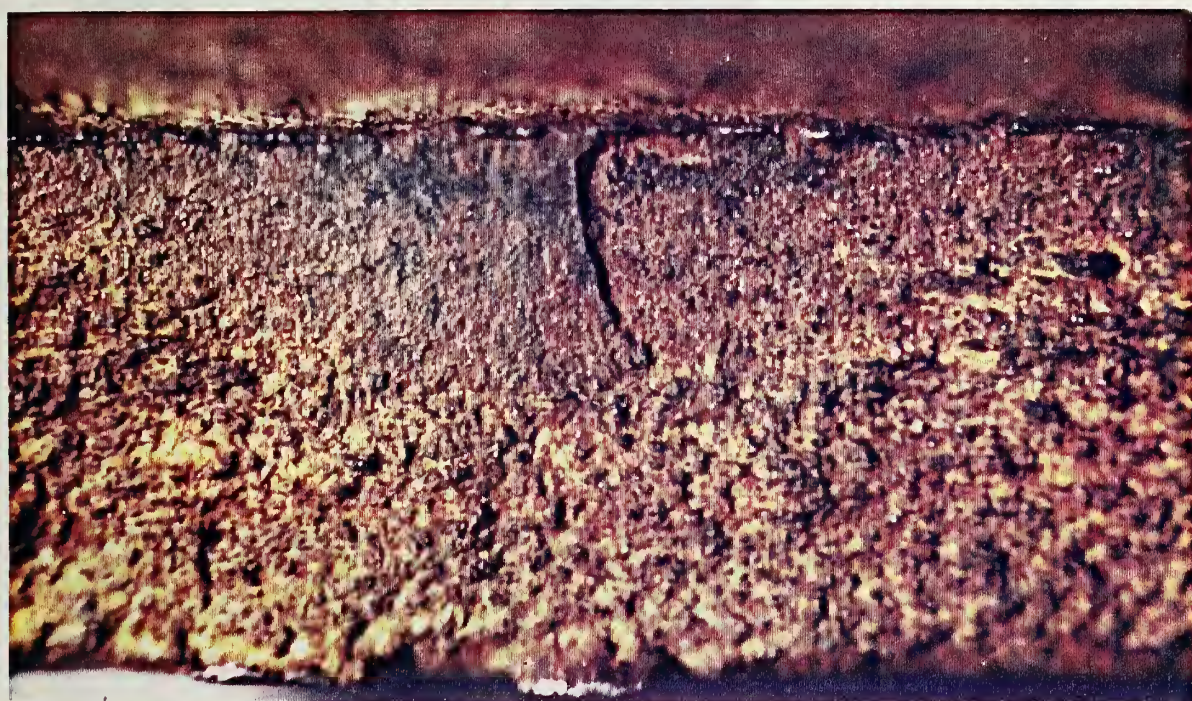
Figure 21. Close-up view of the fracture origin after stripping three cellulose acetate replicas. The black product on the fracture surface became evident as the orange-brown product was stripped away. This view is towards the inside wall.

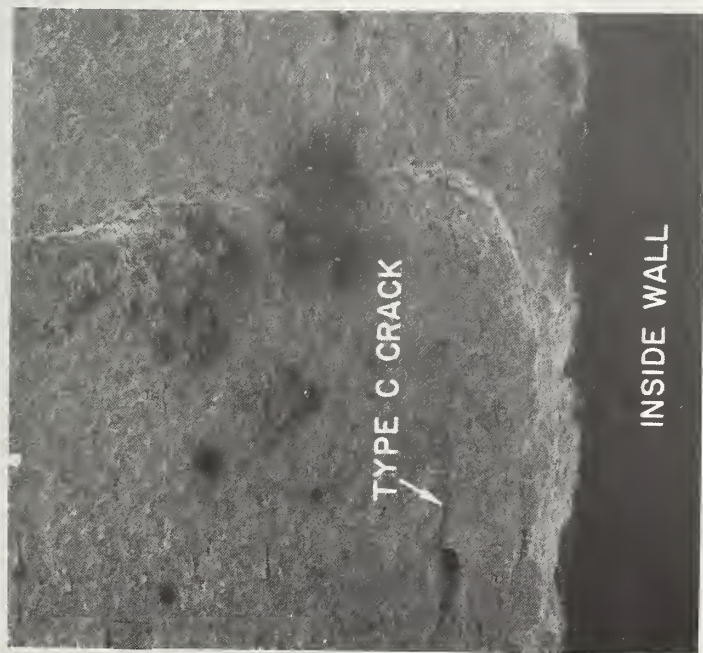
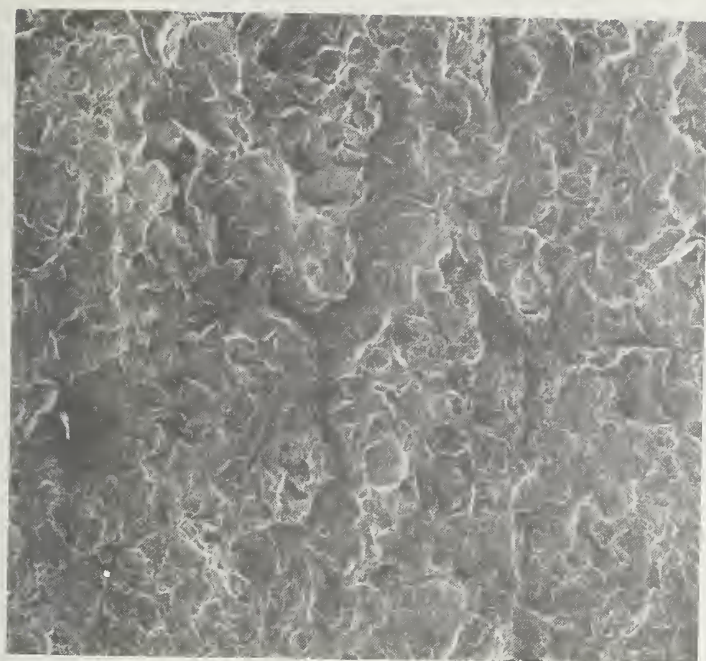
Figure 22. Scanning electron microscope views of fracture origin after cleaning with buffered HCl solution. (a) Region of step, showing a type C crack, (b) Region away from step, showing "plateaus and valleys" structure.

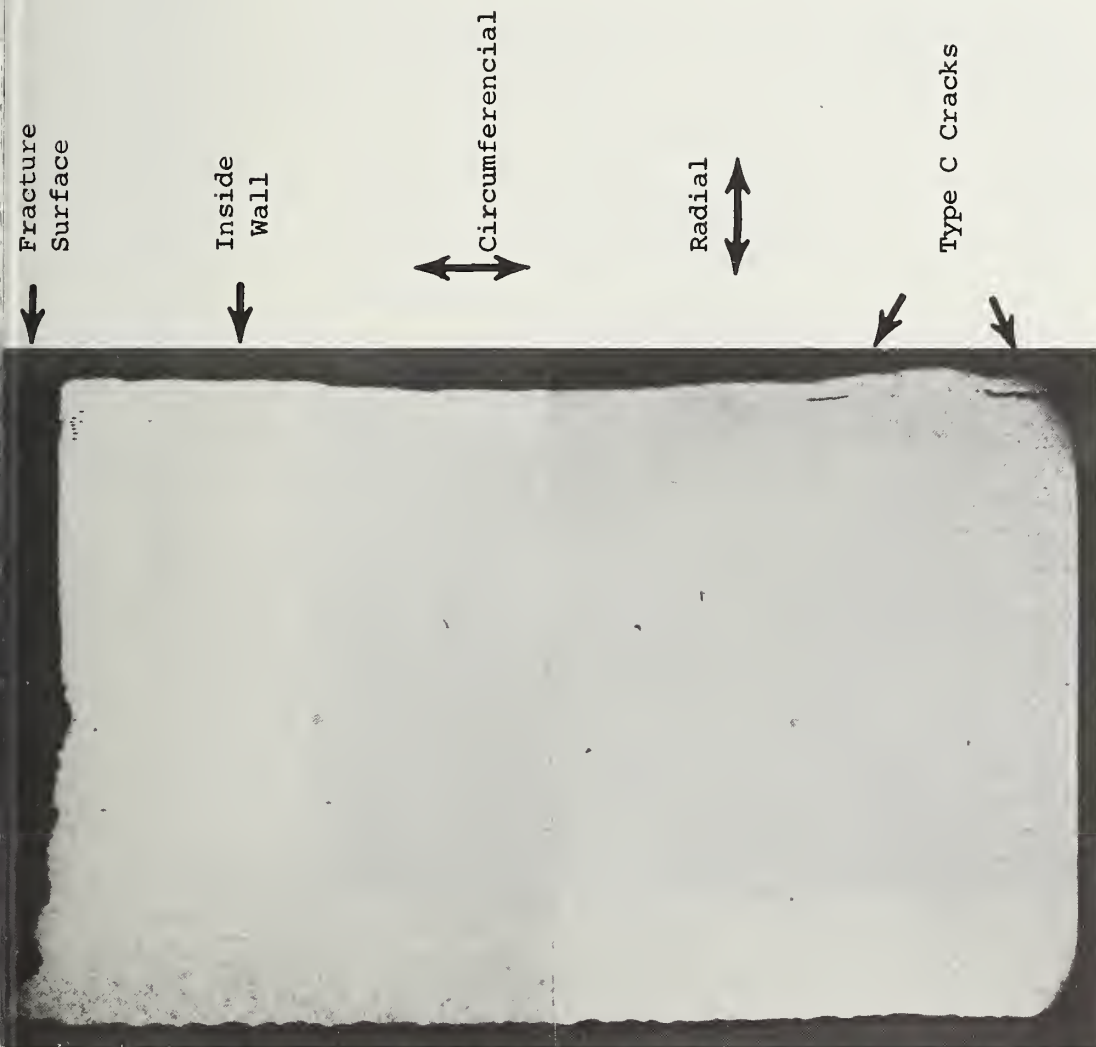
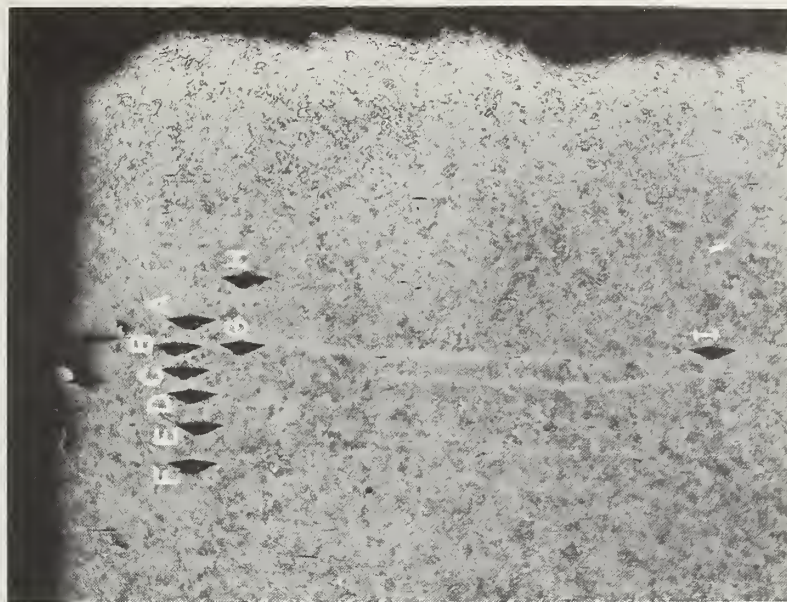
Figure 23. Transverse section through fracture origin. (a) Full thickness view, showing extremely flat fracture surface at origin and two type C cracks in banded region near inside wall. A 45° shear lip appears at the outside wall. (b) Close-up view of the region of the microhardness indentations at the top right in Figure 23a.

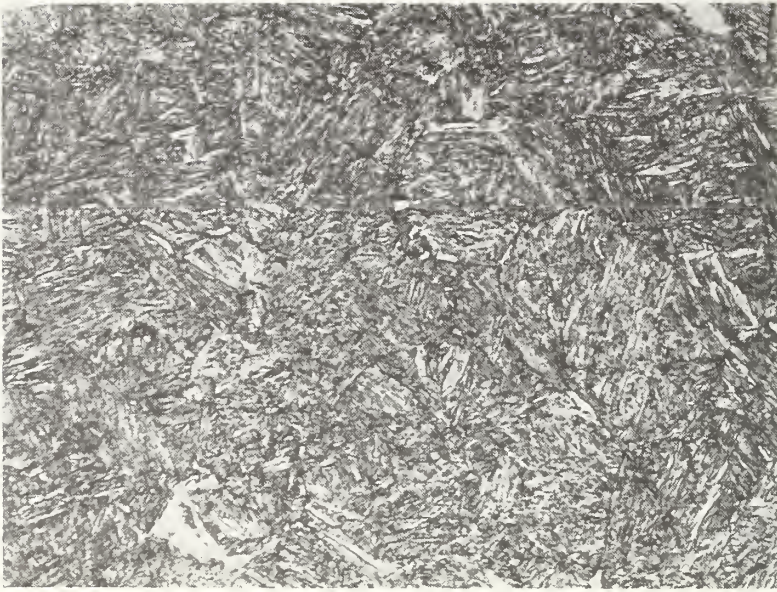
Figure 24. Typical microstructure of tempered bainite found in cylinder 9959.
Etchant: Picral 1000X

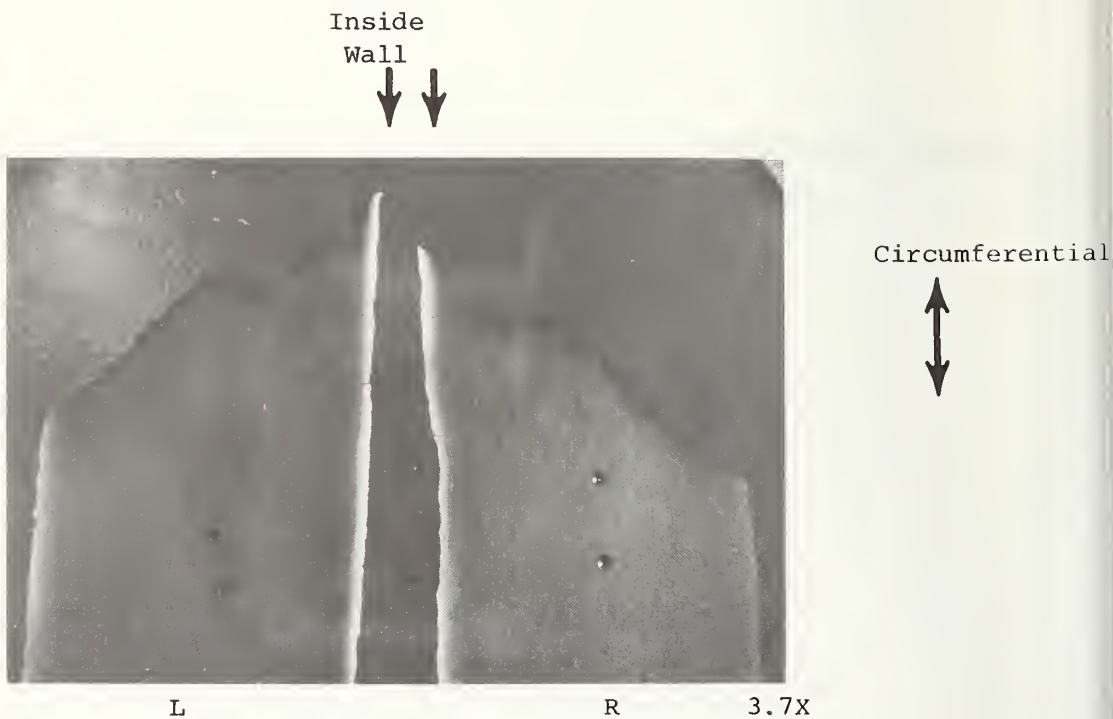
Figure 25. Transverse sections from ends of the segment from piece RR-12 shown in Figure 7c.
